Technology REPORT

Technology Advancements & Gaps in Underground Safety | 2020

Released, May 2020

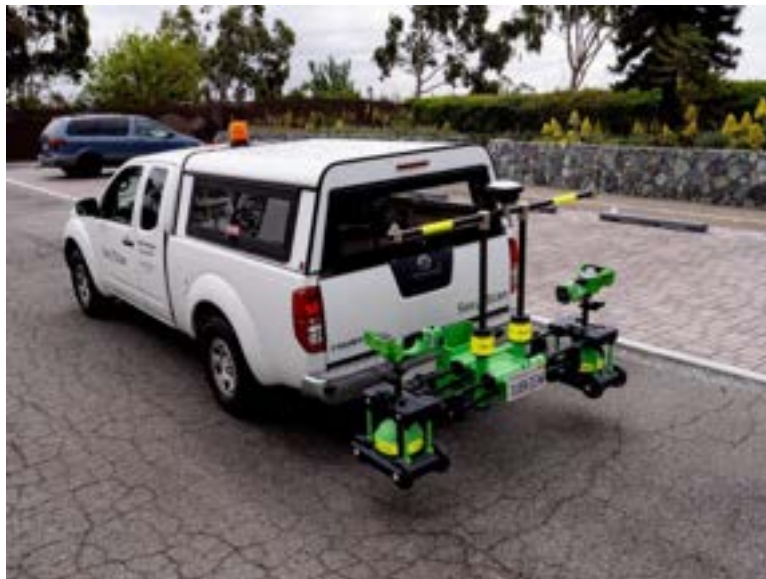
The geolocating receiver includes advanced motion processing that enables a user to passively⁴ locate utilities while driving a vehicle. This allows for a fast way to identify multiple utilities in an area without having to disrupt traffic. Operators can mount two geolocating receivers to a custom vehicle hitch. A survey grade global navigation satellite system (GNSS) instrument between the receivers logs positional data while the vehicle is in motion.

Figure 1—Geolocating receivers mounted to a custom vehicle hitch.

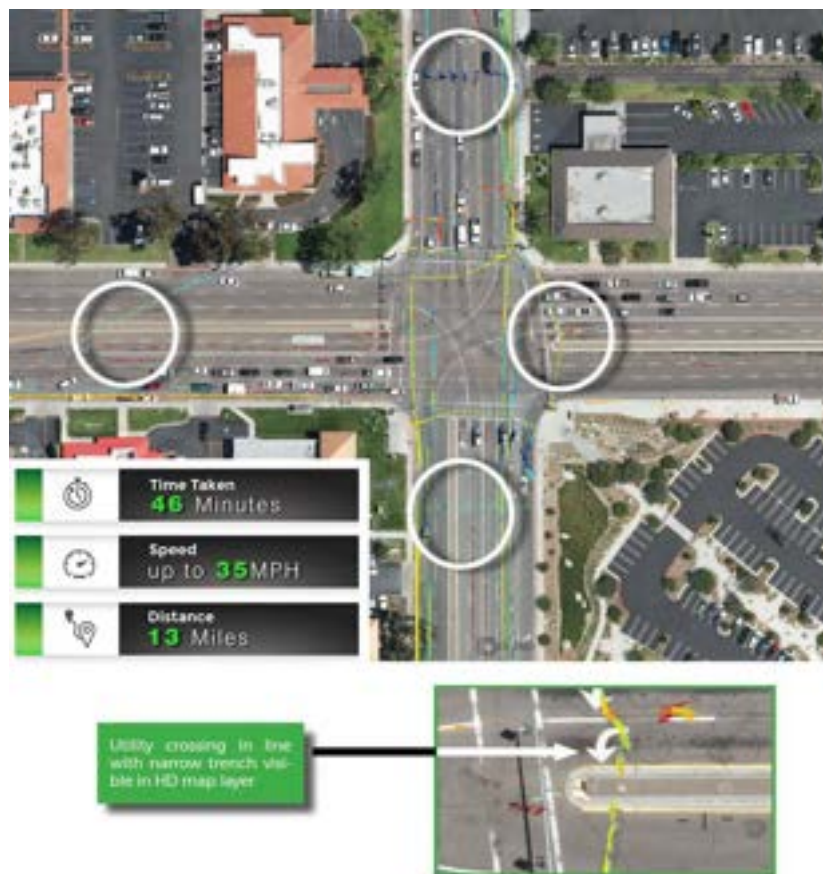
Multiple passes were taken through the intersection over the course of 46 minutes. The aggregated data in SubView revealed the location of electromagnetic signals at various depths throughout the intersection. The resulting map indicated multiple utility crossings, traffic loops, and utilities that run parallel to each street. One estimated utility position appeared where a power line had been recently laid in a narrow trench.

Figure 2—The intersection shows the density of signals detected at various depths, revealing the presence of multiple utilities that cross the intersection.

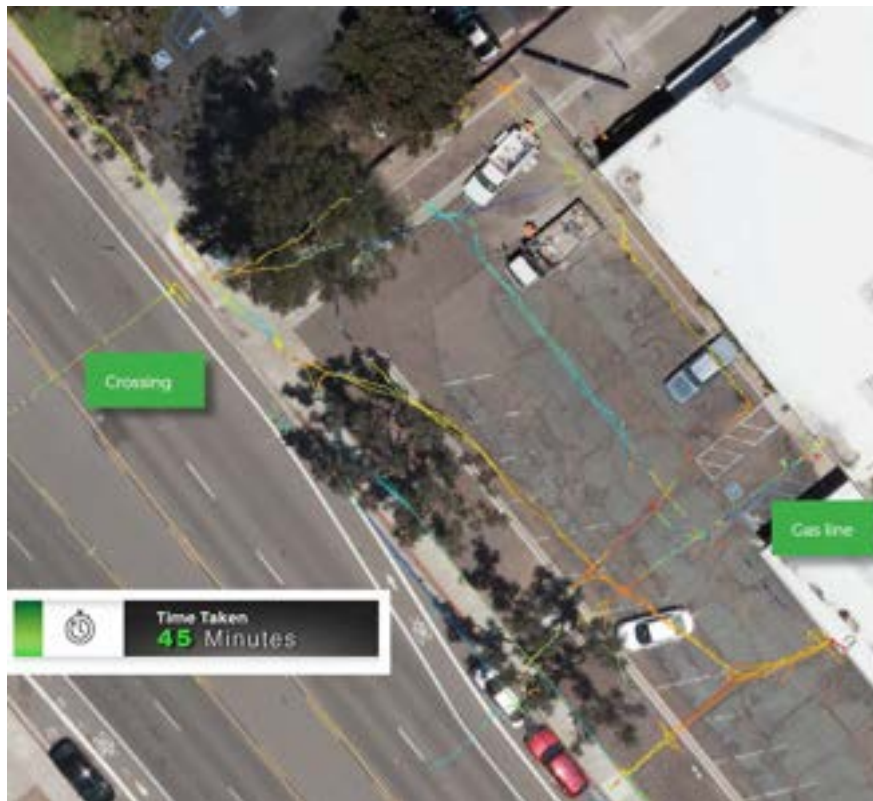
Figure 3—Zoomed in, the map data in SubView shows distinct utilities. Each line was energized with different groups of frequencies.

Testers walked through the parking lot over the course of about 45 minutes to gather all locate data. Using the SubView mobile app as well as the receiver's optical ground tracker, photos of asset locations were appended to the map to create a fuller picture of the locate. In the back parking lot, signal bleed coupled onto a non-targeted line running parallel to the canyon edge but not serving the building. This line was shown on the receiver's interface and in SubView after post-processing. While signal bleed is normally an obstacle, the receiver's gradient-based antenna assembly helps to distinguish utilities that are incidentally energized.

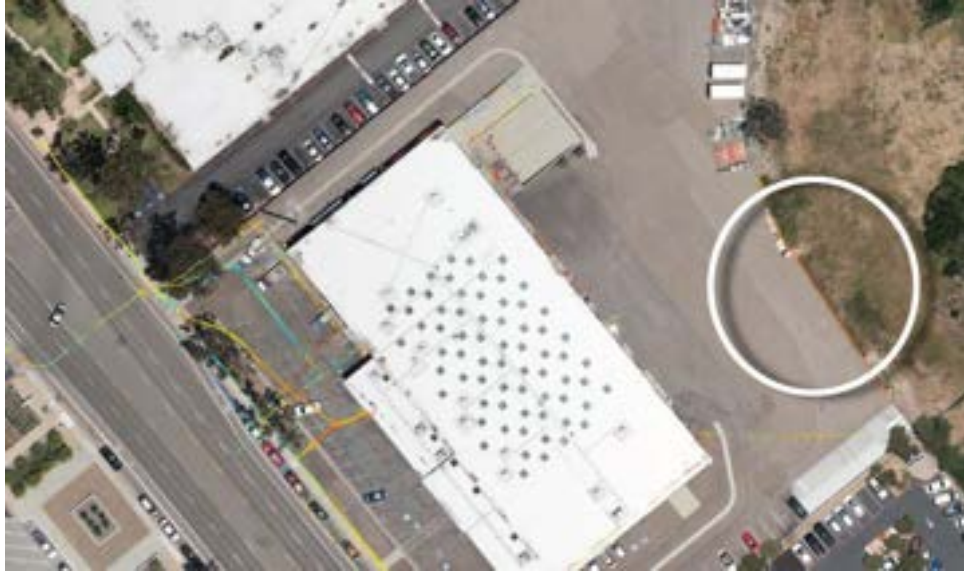
Figure 4—The map data in SubView shows multiple distinct utilities throughout the front and back parking lots. A line running along the canyon edge reveals a separate utility energized via signal bleed.

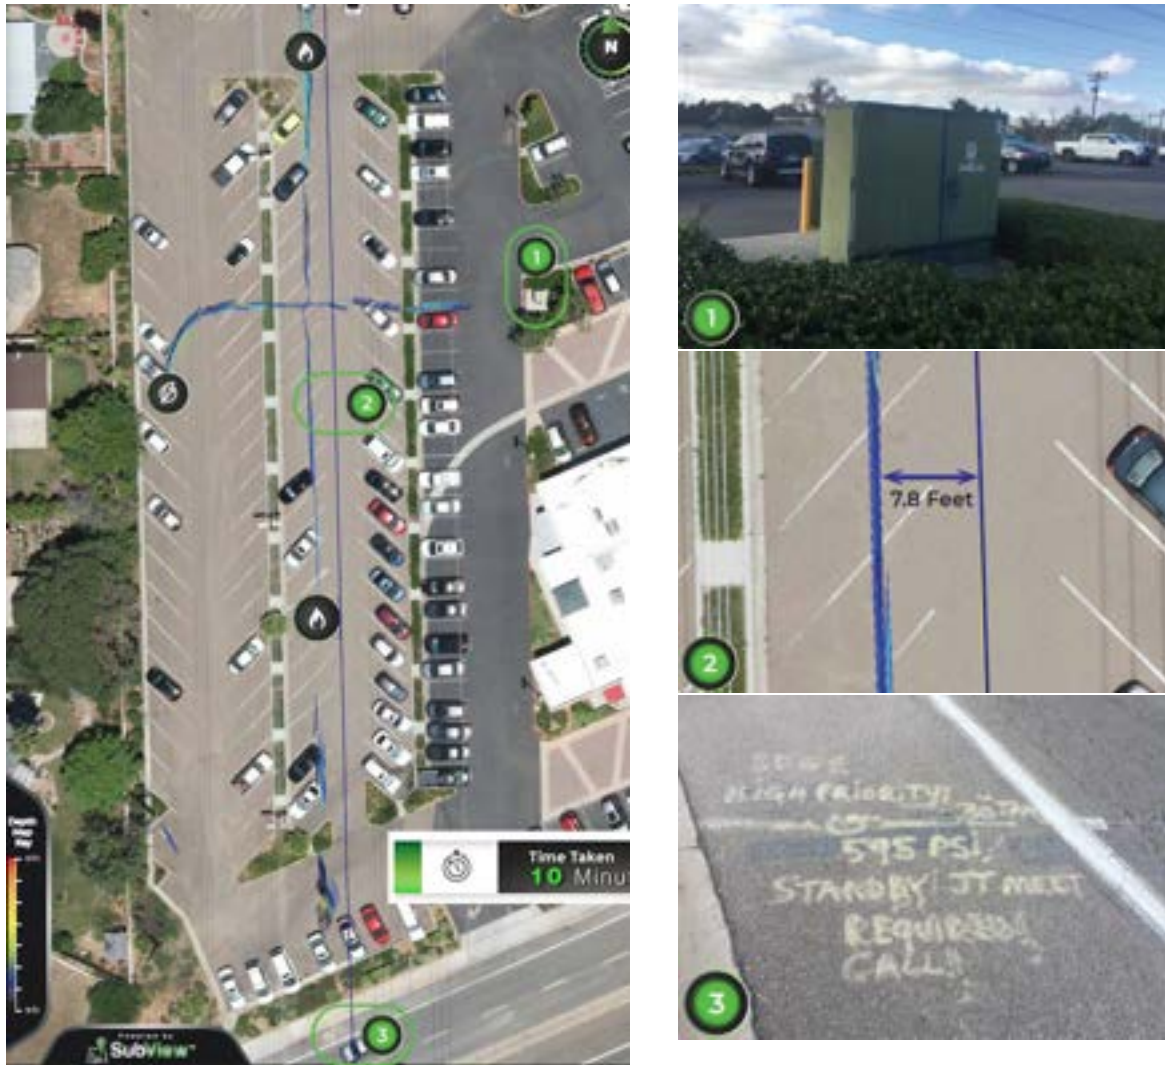
The locate map in SubView reveals the location of the SDG&E transmission pipeline at 7.8 ft (2.4 m) west from its indicated position on the pipeline map, well outside of the utility's tolerance zone.⁶ The depth is approximately 7 ft (2.1 m); no depth information is available on the pipeline map. The utility's estimated position in SubView lines up with paint markings in the street from a locate performed by SDG&E.

Data gathered from the receiver shows an additional buried utility that crosses over the pipeline, which terminates at an electrical box, indicating an electrical line.

Figure 5—The map in SubView reveals a shallow electrical line that crosses over the pipeline (1). The transmission pipeline lies approximately 7.8 ft to the west of the position in the SDG&E map (2). The pipeline's location lines up with paint markings in the street from a recent locate (3).

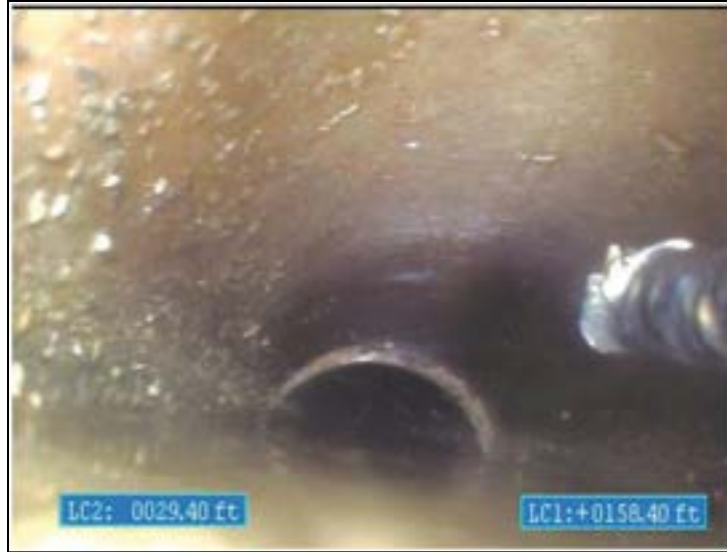
Water obstructions (Figure 6) generally occur when there are sags or small obstructions within the sewer lateral. The ability to see below the water line is required to confirm that no cross bore is present. If the water could be extracted, then the optical cameras would be able to take imagery of the lower half of the sewer lateral, allowing for confirmation of the presence or non-presence of a cross bore.

Figure 6—Example of water at the base of the interior of a sewer lateral as viewed by an inspection crew's camera.

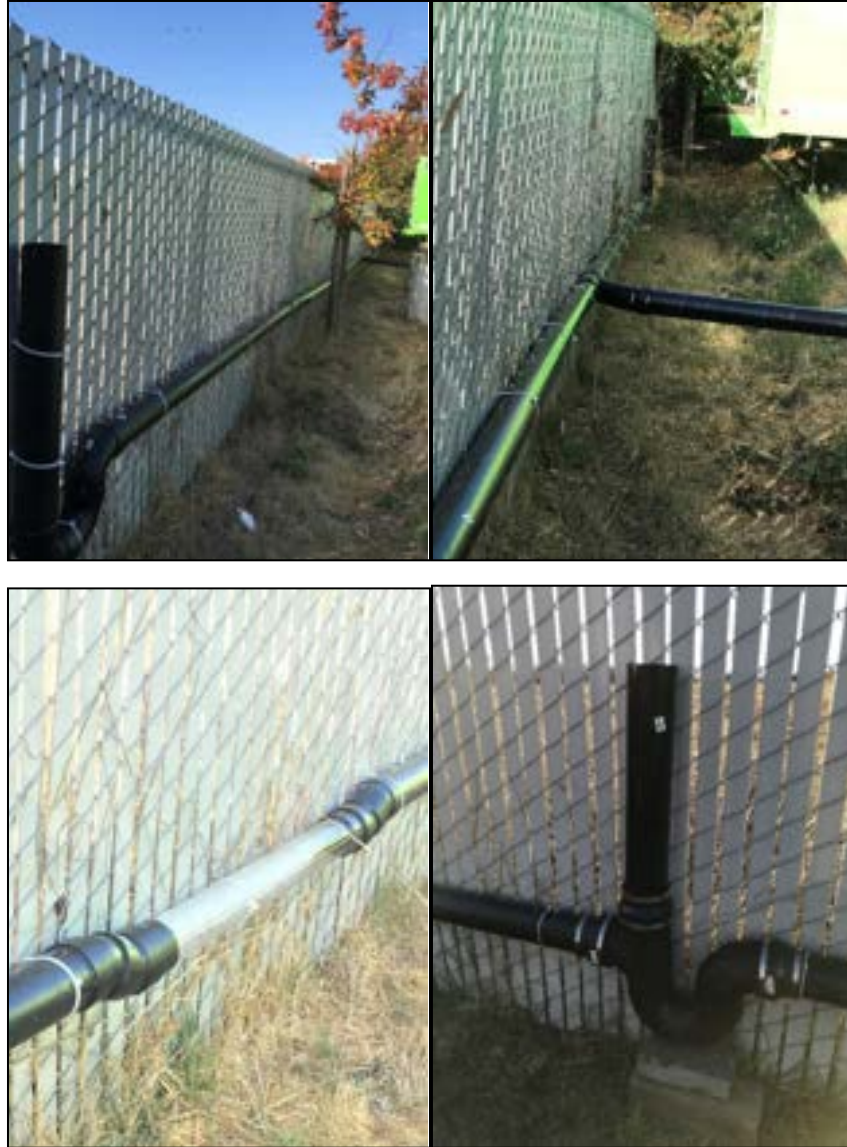
ServPro built a sewer lateral prop for testing the WET at its local headquarters in Cotati, CA. The testing prop was constructed of 4-in.-diameter PVC and was 53 ft in length. The testing prop included foundation and curb clean outs, a sag, and a branch. Water was fed into the system to simulate partial or fully flooded water obstruction (Figure 8).

*Figure 8 (clockwise)— Foundation access.
 Branch in sewer lateral.
 Curb access with p-trap.
 Sag in sewer lateral using clear PVC for viewing water extraction
 in progress.*

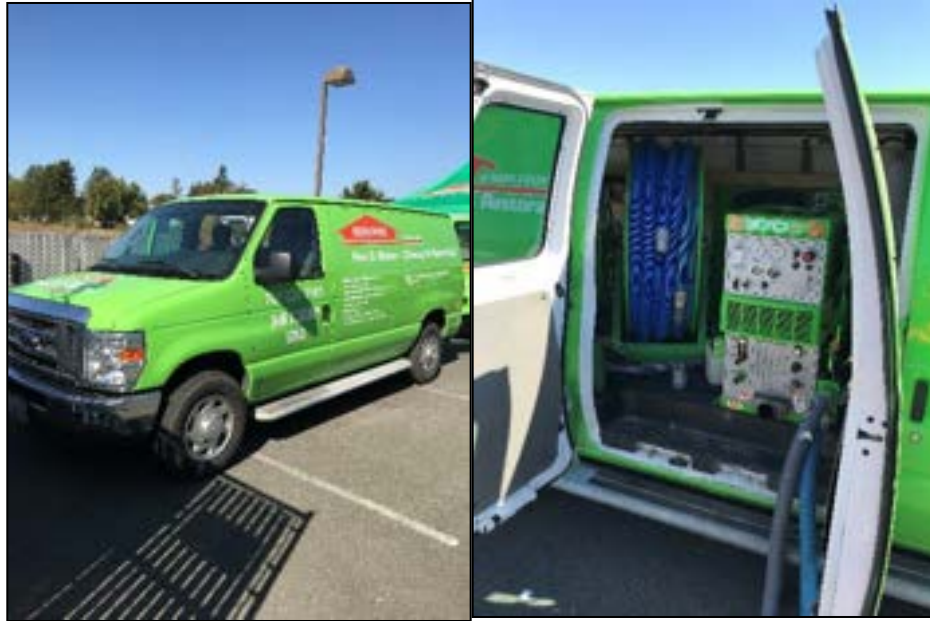
ServPro already has existing pumping capabilities built into its fleet vehicles to support its core business. Additionally, ServPro has existing arrangements for disposal of waste (black) water per state and federal requirements. The project utilized their existing system installed into a standard van (Figure 9).

Figure 9 (left-right)—ServPro van and the interior showing vacuum hose and pumping system. Water storage tank (not pictured) is directly behind the pump.

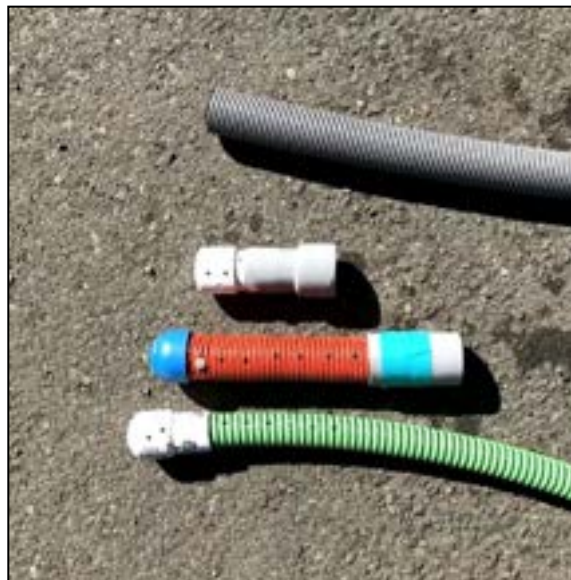
A variety of hose types, sizes, and tips were developed and tested. Hose sizes included 1-in., 1.25-in., and 1.5-in. diameter. All hoses were 50 ft in length and could be connected if longer distances were required. Hoses were perforated to allow water to be extracted while the hose lay on the inside surface of a sewer lateral. Tips were designed to prevent larger objects such as rocks and gravel from clogging the hose. Figure 10 shows the hoses and tips.

Figure 10—Hoses and tips used during initial testing. Perforations can be seen on the hoses.

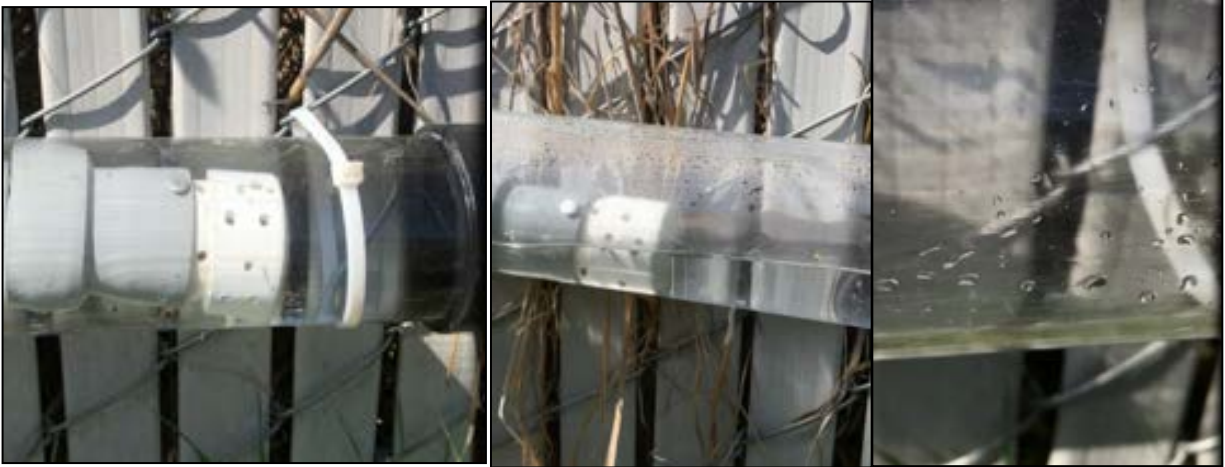
Water was introduced and the sewer lateral was tested partially filled and completely flooded. The hose easily navigated the sag and branches. Testing demonstrated water extraction was sufficient such that a successful camera inspection would be possible (Figure 11).

*Figure 11 (left-right)—Extraction hose within flooded sewer lateral prop.
Water partially extracted from sewer lateral prop.
Close-up of sewer lateral prop following extraction with no remaining water,
allowing for successful camera inspection.*

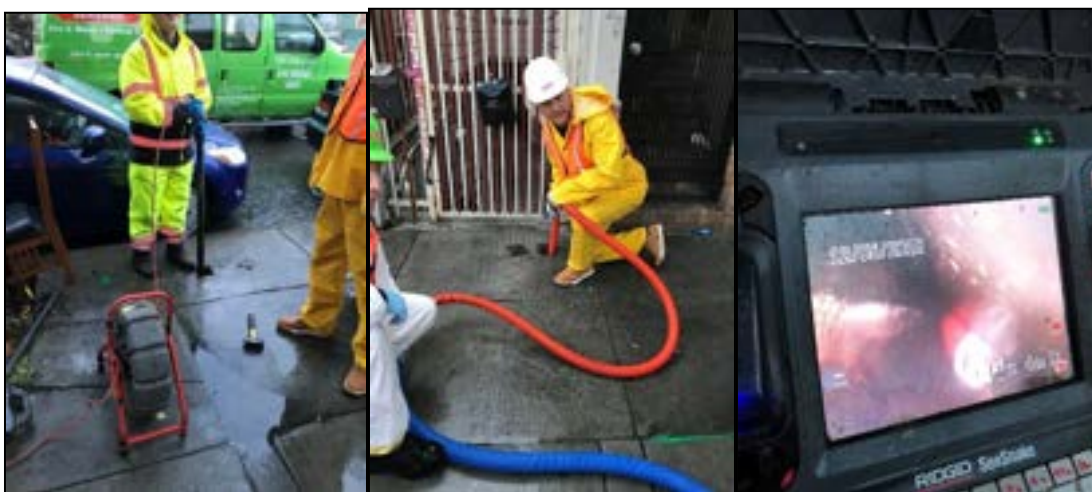
The single, accessible location proved invaluable as a first testing of the WET. The site consisted of a sewer lateral with two accessible cleanouts, one at the property's foundation and another located at the curb. The sewer inspection crew inserted its optical camera at the curb location and confirmed the presence of water within the sewer lateral going back toward the property's foundation. While the optical inspection camera remained in the sewer lateral, the ServPro crew inserted its WET at the foundation cleanout, feeding it into the sewer lateral toward the street. With the optical camera, real-time imagery was captured of the WET extracting water (Figure 12). Once the water was fully extracted, the crew successfully completed its inspection, confirming no cross bore present at this location.

*Figure 12 (left-right)—Inspection crew inserts optical camera at curb cleanout.
ServPro crew inserts WET at property line cleanout.
Real-time view of optical camera screen showing water being extracted.*

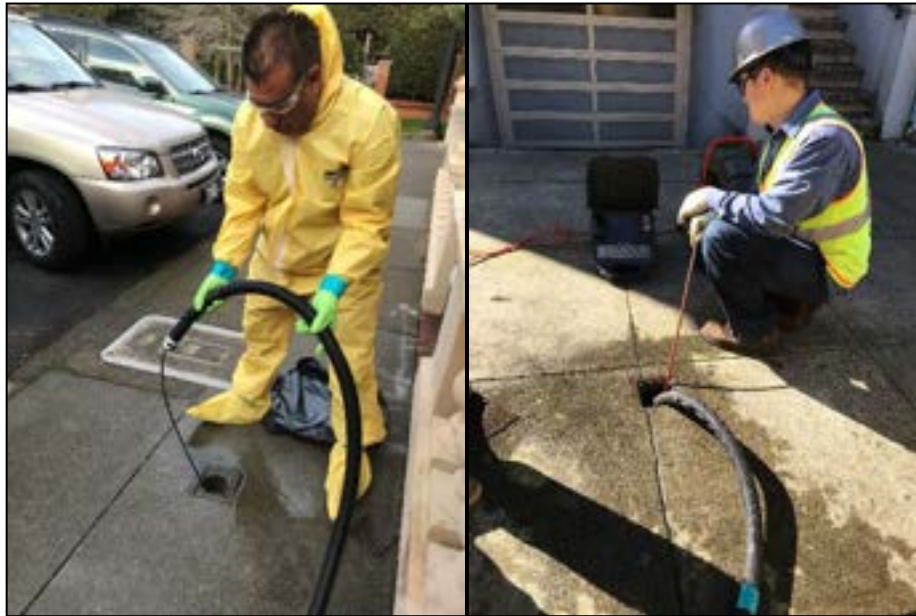
Generally, the WET navigated the p-trap with little or minimal effort. Following testing at its Cotati HQ and from prior field experience, ServPro had developed an adaptation of the hose that included the assistance of a plumbing snake (Figure 13). This adaptation was developed to assist with navigation of the p-trap. Additionally, during testing the snake was able to gently loosen sand and gravel that had accumulated within the sewer lateral, making extraction possible and increasing the utility of WET. In

two instances, the WET was used to extract water simultaneously while conducting the camera inspection. In one such instance at a multifamily complex, the water needed to be extracted continuously because water usage in the building was continuous and obscured the inspection camera (Figure 13). Ultimately, the sewer lateral inspector conducted a successful inspection of the sewer lateral and determined no cross bore was present.

Figure 13 (left-right)— *Plumber’s snake modification to the hose to assist with p-trap navigation. Water extraction and camera inspection occurring simultaneously at a multifamily complex.*

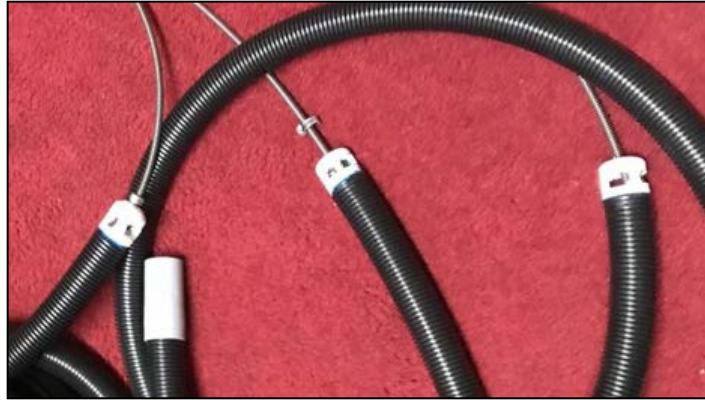
ServPro successfully designed, built, and tested a water extraction tool (WET) that consistently navigated sewer laterals in the field and sufficiently extracted water within the sewer lateral such that inspections of the bottom half of the sewer lateral were successfully completed. A variety of hose types, sizes, and tips were developed and tested. Hose sizes included 1-in., 1.25-in., and 1.5-in. diameter. The 1.25-in.-diameter hose proved the most effective and easy to use. All hoses were 50 ft in length and could be connected if longer distances were required. Hoses were perforated to allow water to be extracted while the hose lay on the inside surface of a sewer lateral. Tips were designed to prevent larger objects such as rocks and gravel from clogging the hose. Lastly, to assist with navigation of the p-trap, a plumber’s snake was incorporated into the design (Figure 15).

Figure 15—Final 1.25-in.-diameter hose configuration with plumber's snake.

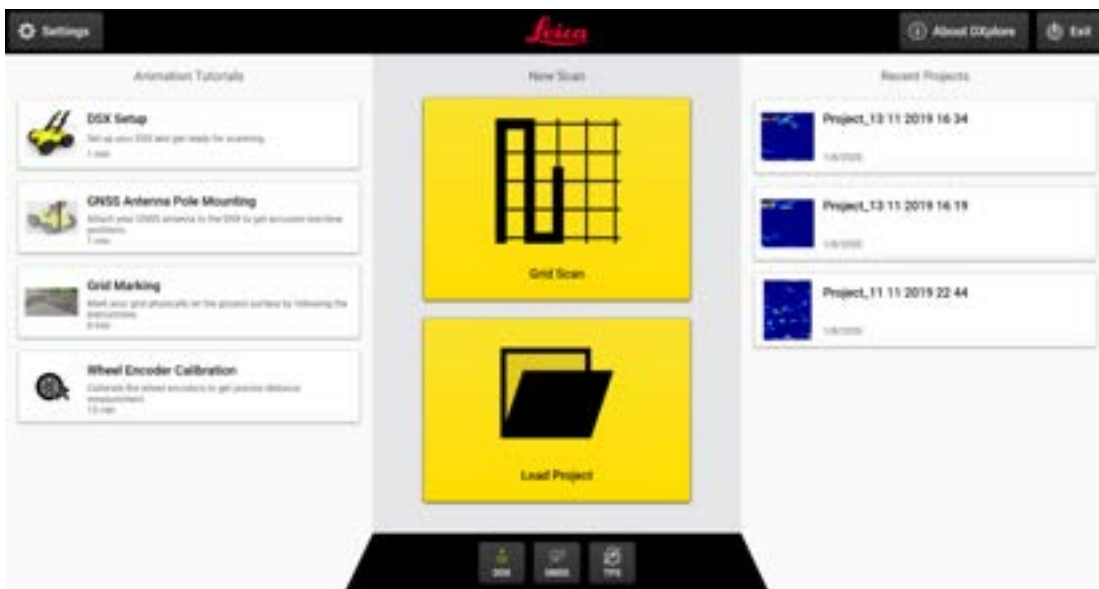
The software’s easy-to-use tutorials cover the main aspects of using and collecting data with the GPR system. The user will have confidence to set the system up, connect a GNSS/GPS antenna to the controller, and correctly mark the acquisition grid for accurate and reliable data collection. Training time has been dramatically reduced with this software.

Figure 21—Home screen of the DXplore.

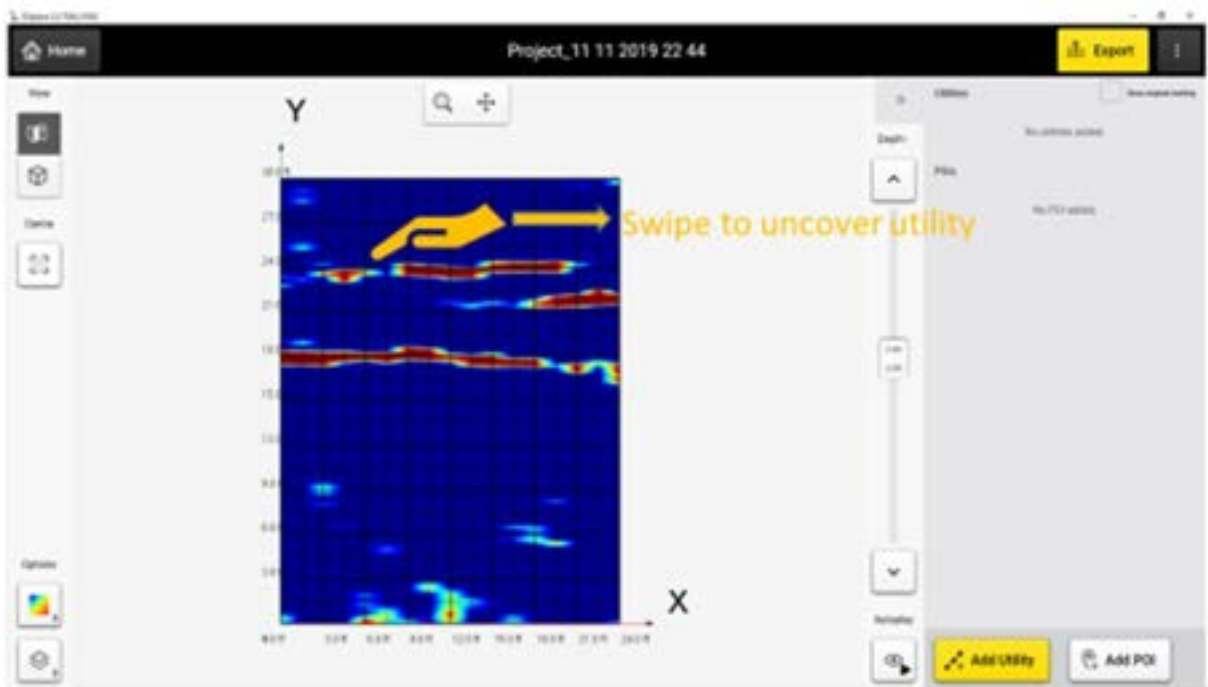
To determine if a utility is present, the operator simply uses their finger to swipe across the screen where they believe the software should show an indication of a utility (Figure 22). At this point, a unique software algorithm determines if the path drawn is a utility. If the software confirms a utility, it draws it on the map. Additionally, the software also confirms the actual path of the utility, not necessarily where the operator drew it. The software alerts the operator if it does not confirm that a utility is identified.

Figure 22—Screen shot of finger swipe to identify utility.

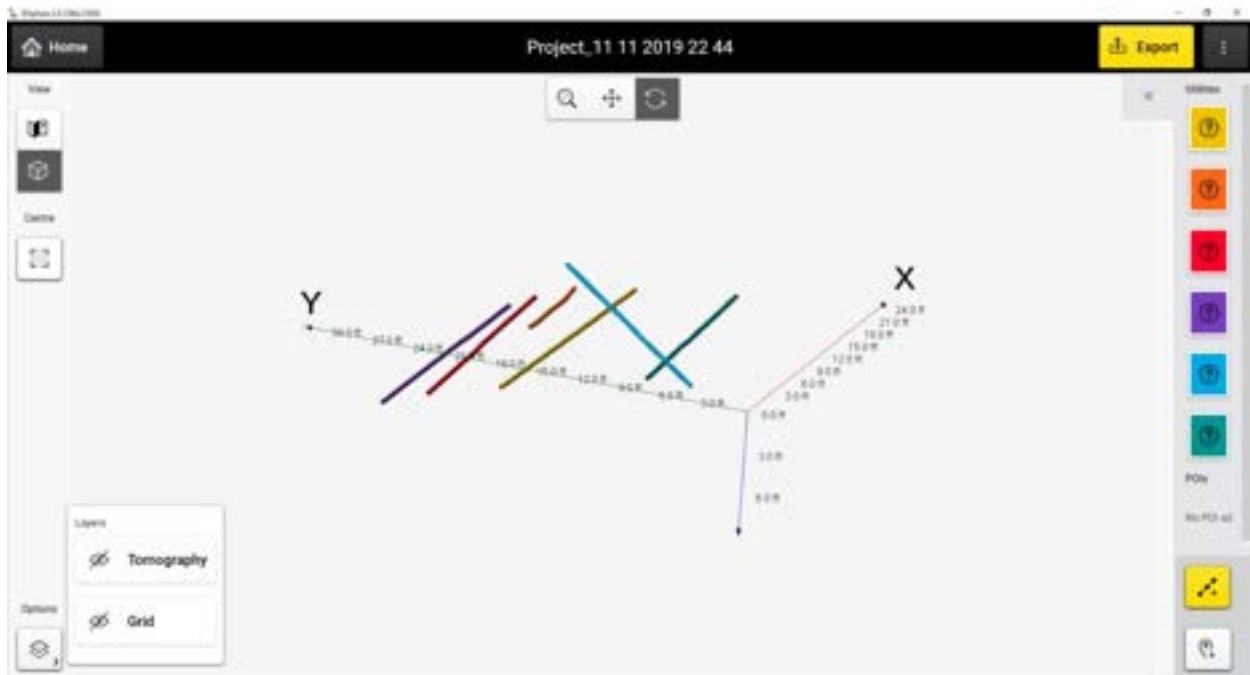
Once all utilities have been drawn, the utility line can be viewed in a 3D space. The software displays each utility's GNSS/GPS or TPS position and the calculated depth. This allows the operator to see how the utility tracks and interacts with other utilities in the subsurface.

Figure 23—3D view of detected utilities.
